Archaeological Evaluation at Tal-Qares, Mosta
i.c.w. Rationalisation Scheme Map 27, Site E

Preliminary Report prepared by
Nathaniel Cutajar and Mevrick Spiteri

Superintendence of Cultural Heritage

May 2014

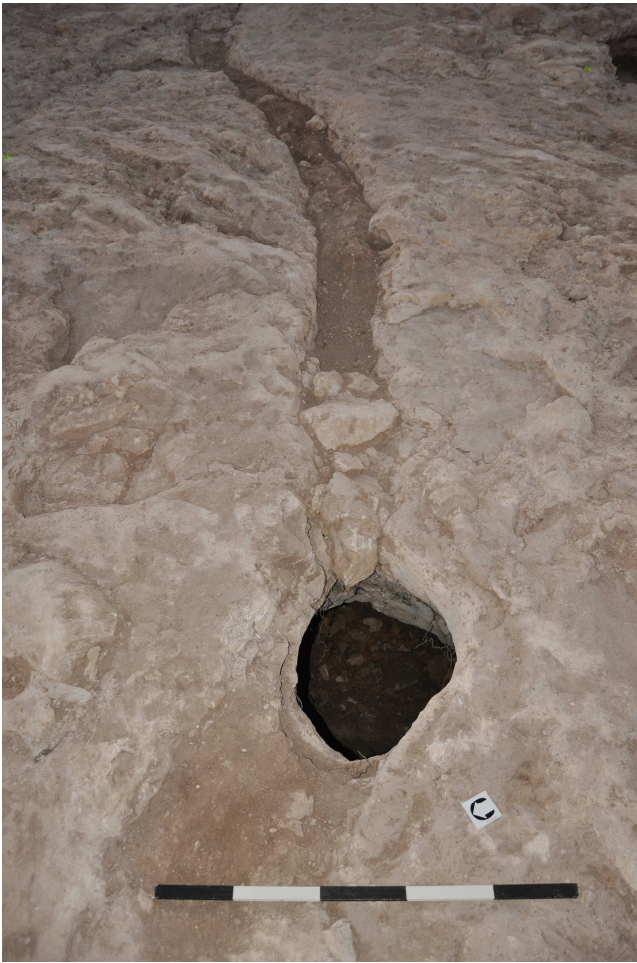
Plate 1 – Silo pits

Some features of this settlement (1 to 4 above) are typical of Middle/Late Bronze Age sites (Borg in-Nadur 1500-750 BC).

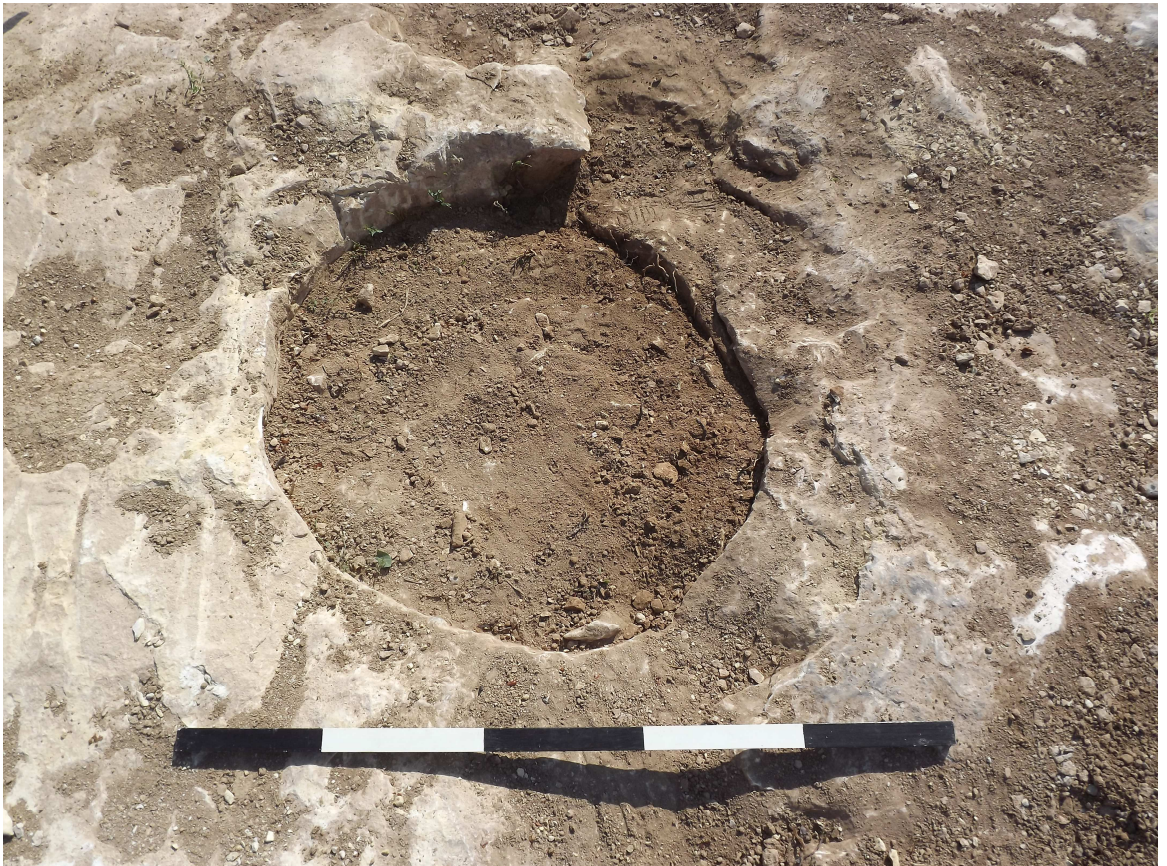
Plate 10 – Shallow quarrying and vine trenches uncovered in Field C

- Various shallow quarry marks (Feature 28 – see **Plate 10**);
- A line of agricultural vine trenches on the southern limit of the property (Feature 29 – see **Plate 10**);
- Possible ancient water cistern (Feature 30 – see **Plate 10**).

Recommendation: There is no objection to the inclusion of Field C in the Development Zone subject to the following:

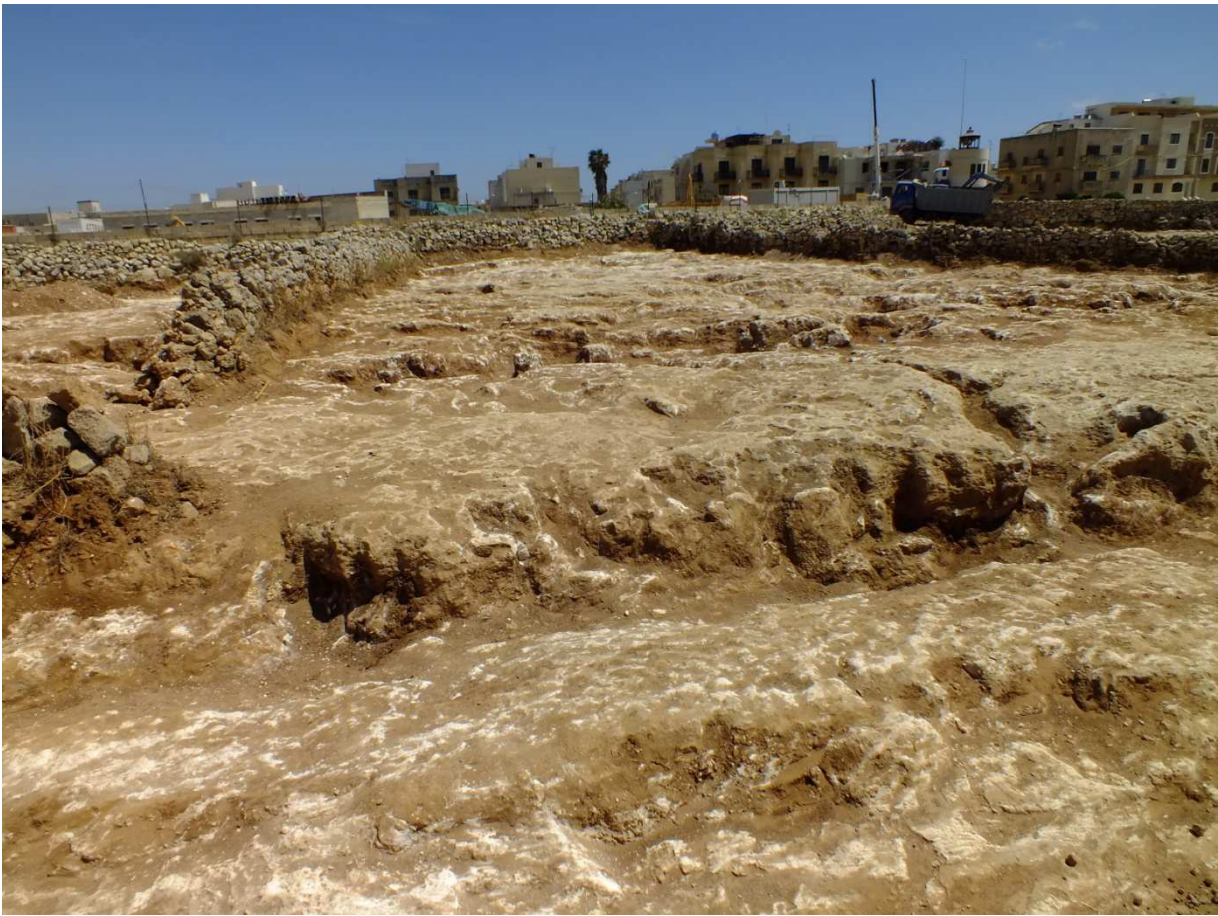
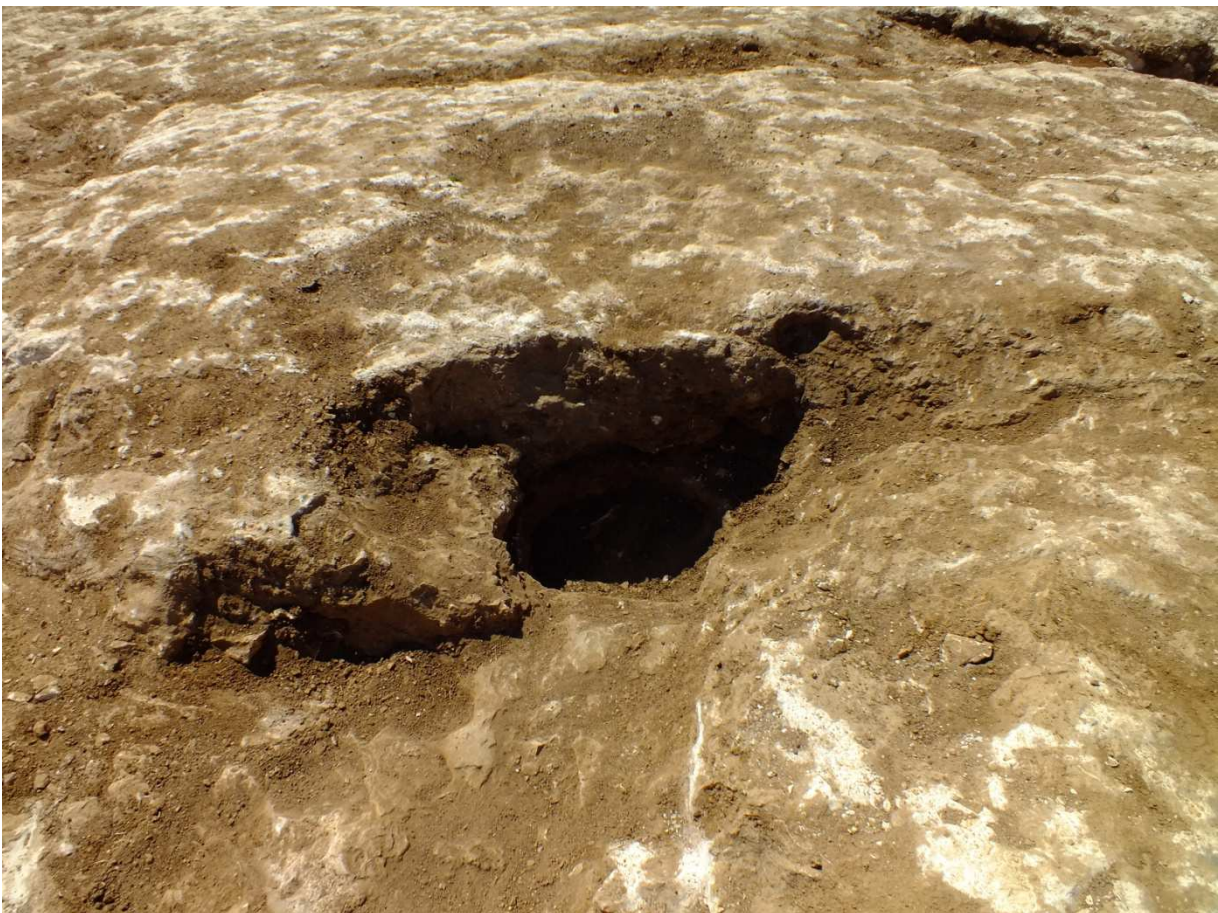
Plate 2 – Foundation walls of an ancient structure (Feature 5)

Most of the archaeological features identified in Field A belong to an Early Roman rural settlement (third/second century BC) which included an extensive water management system (water cisterns and water channelling – Features 8 to 12) and structural remains (Features 5 and 6). The residential character of this settlement is indicated by the large amount of domestic ceramics fragments, particularly cooking ware, found within the excavated features.

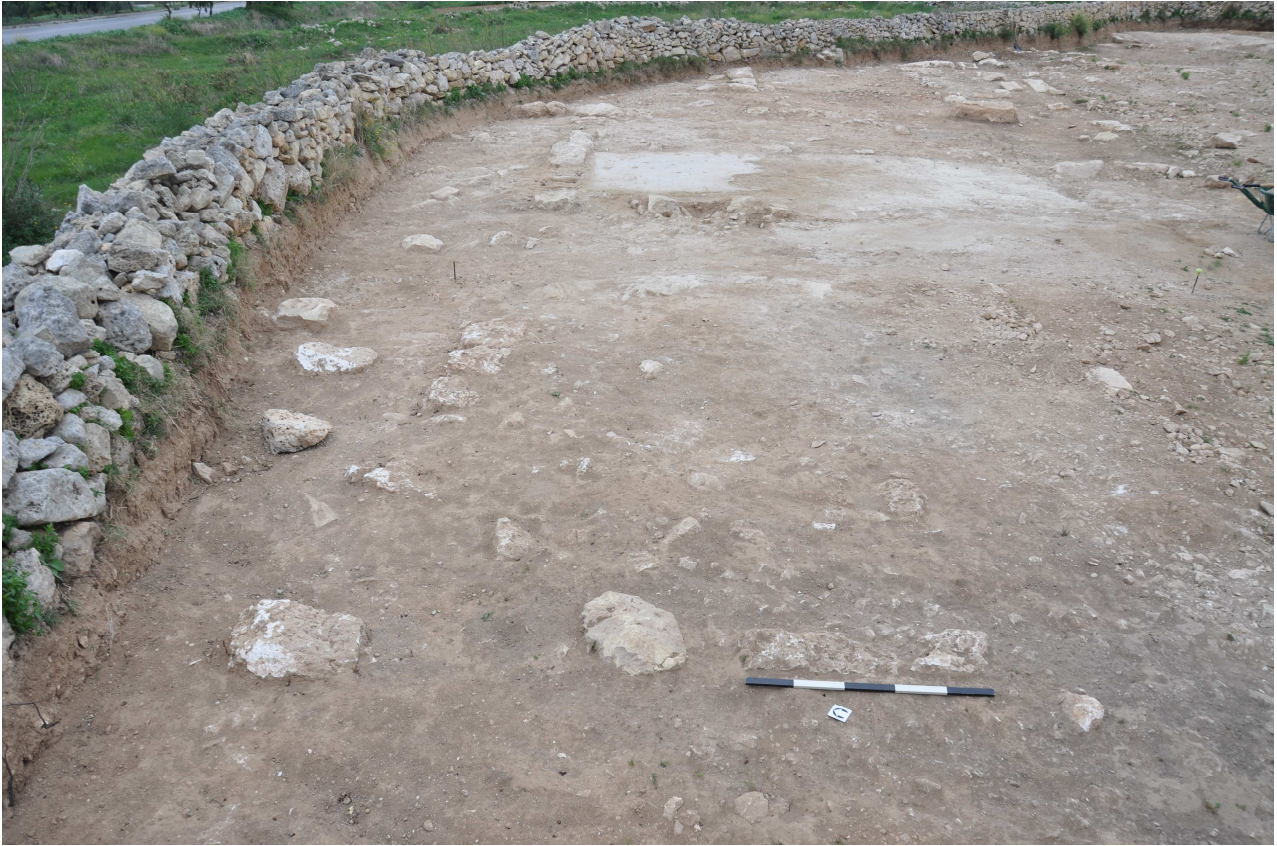
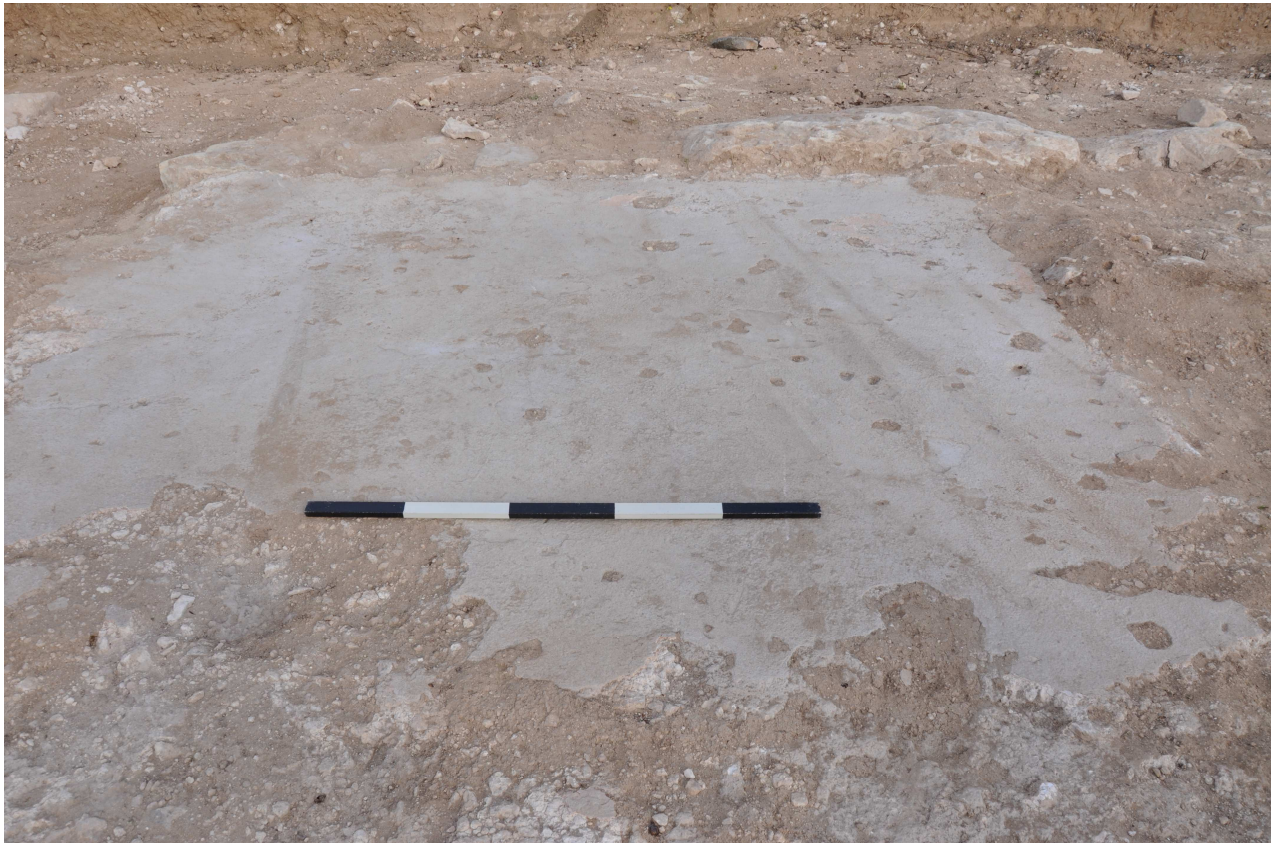
Plate 4 - Detailed views of the remains of a kiln (Feature 7)

Furthermore the presence of a circular kiln structure (Feature 7) indicates that some artisanal activities were also being carried out within this Early Roman settlement.

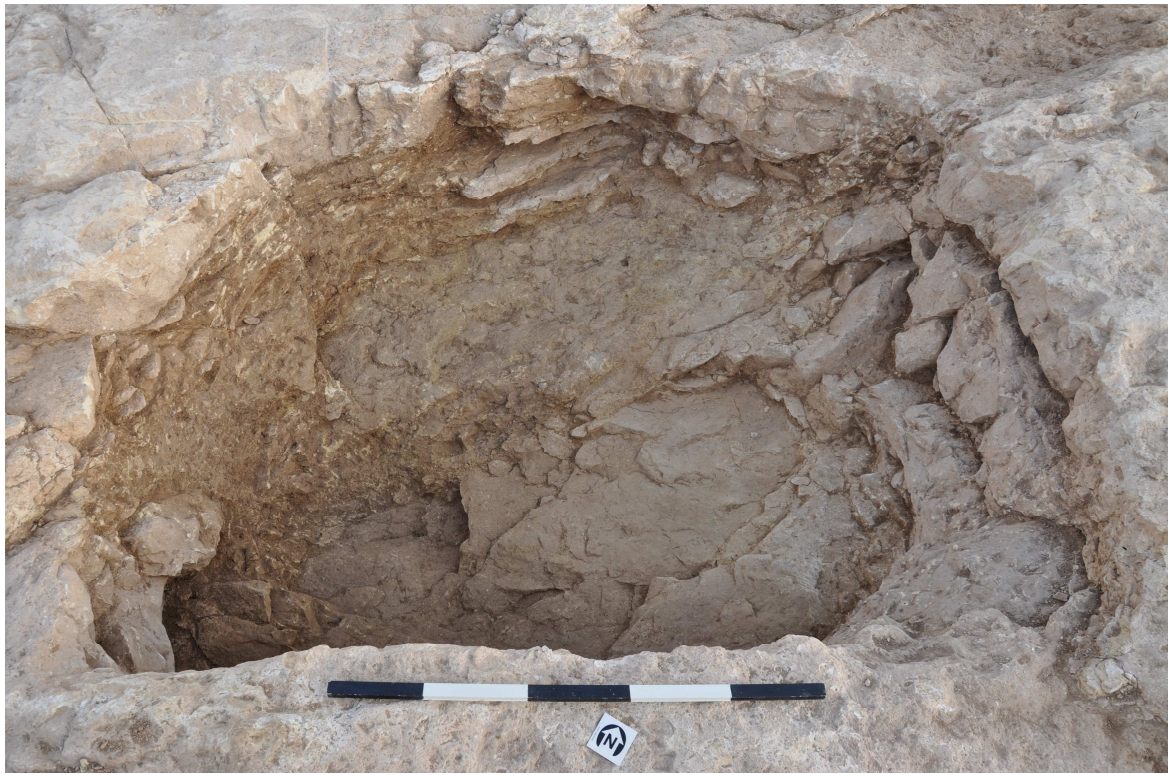
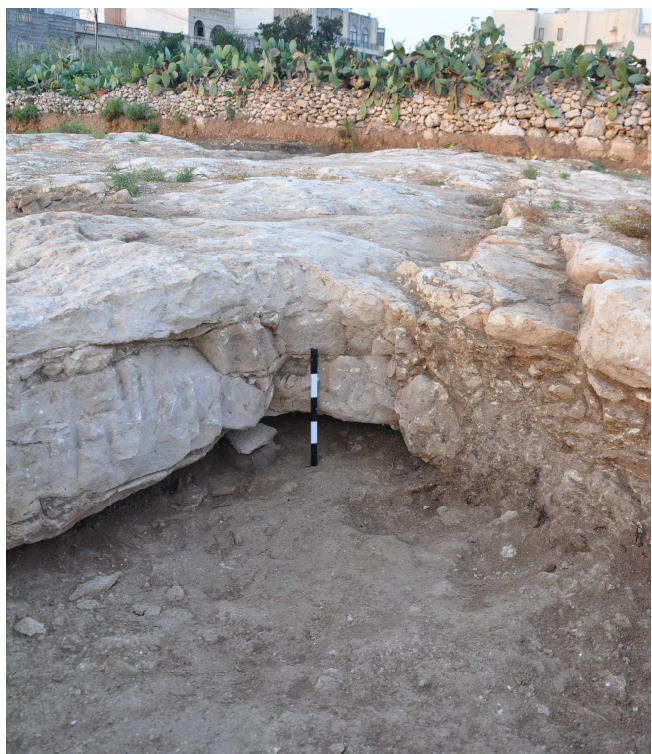
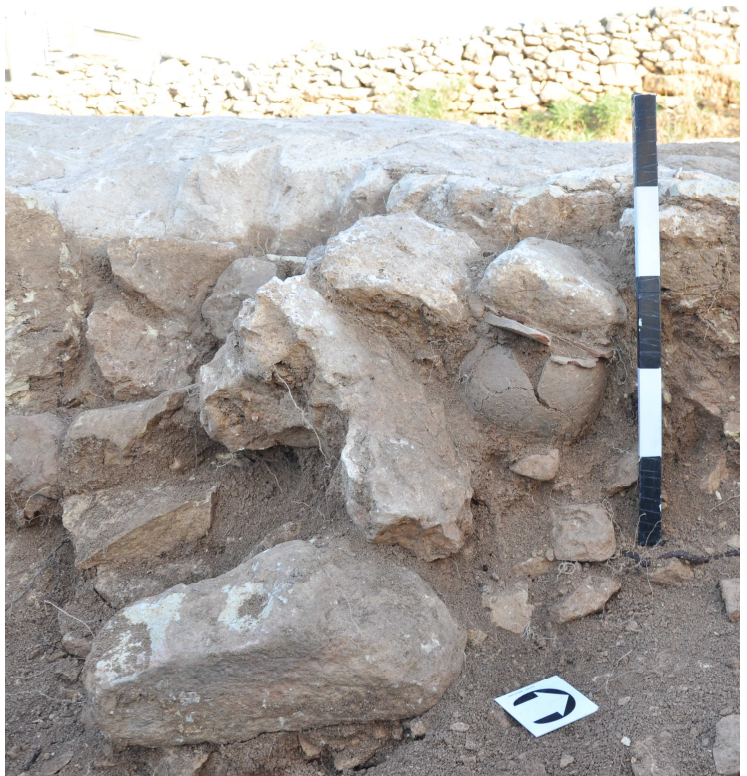
Plate 7 – Quarrying and Vine Trenches in Field A

Extensive traces of ancient shallow agricultural and quarrying practices were also found across large areas within Field A (Features 13 to 21).

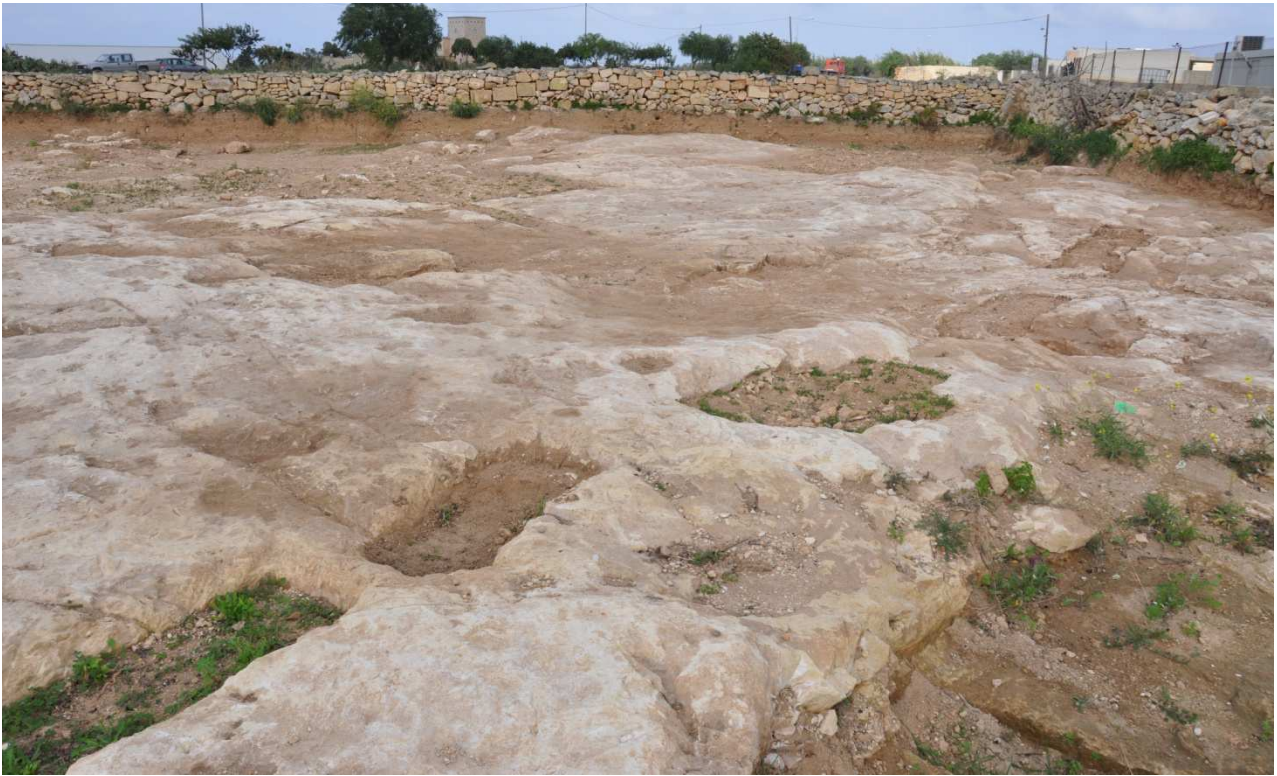
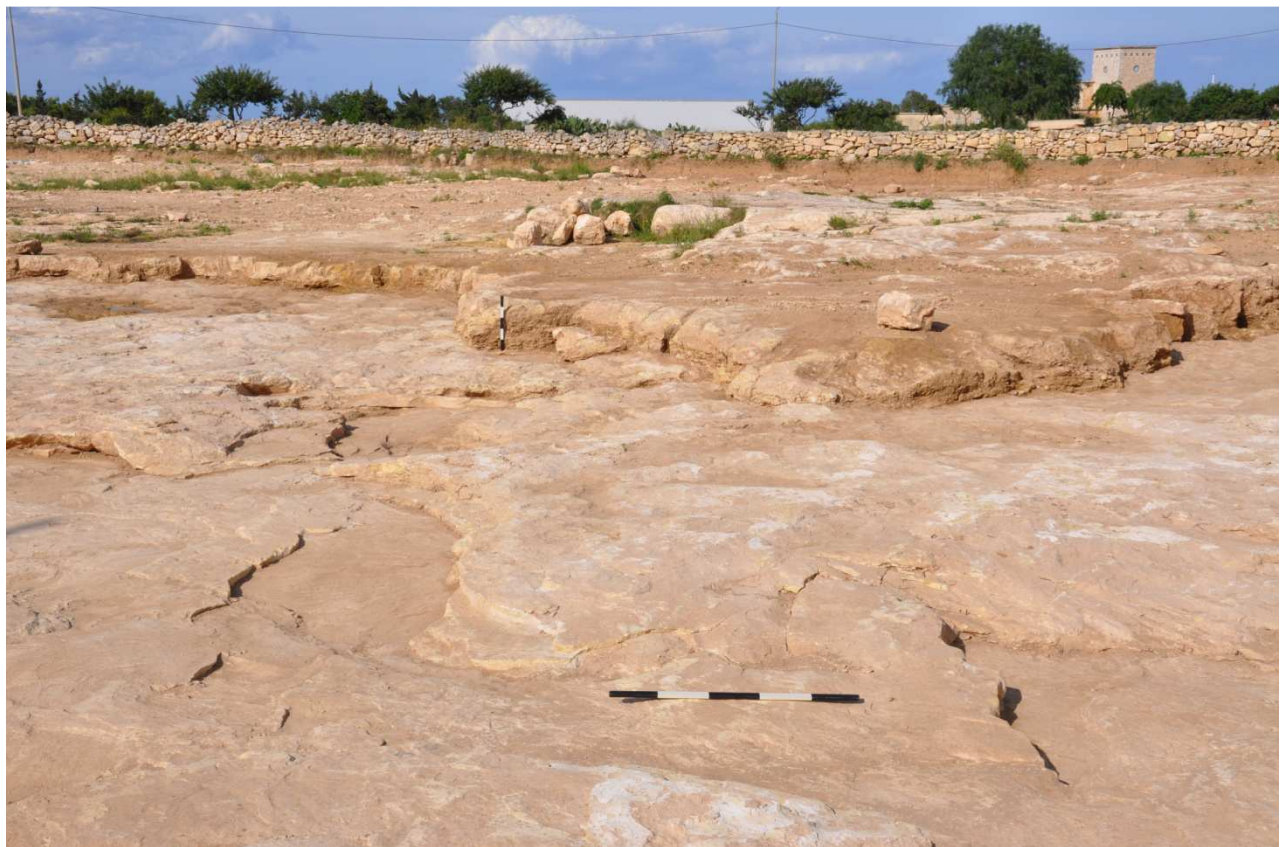
Plate 8 – Large ashlar blocks within various stretches of the rubble walls

The rubble walls (Features 22 to 25) were constructed in a later historical moment, when the area of Tal-Qares was transformed into arable fields. Large rectangular limestone blocks extracted from the ancient remains and reutilised in the construction of the agricultural rubble walls.

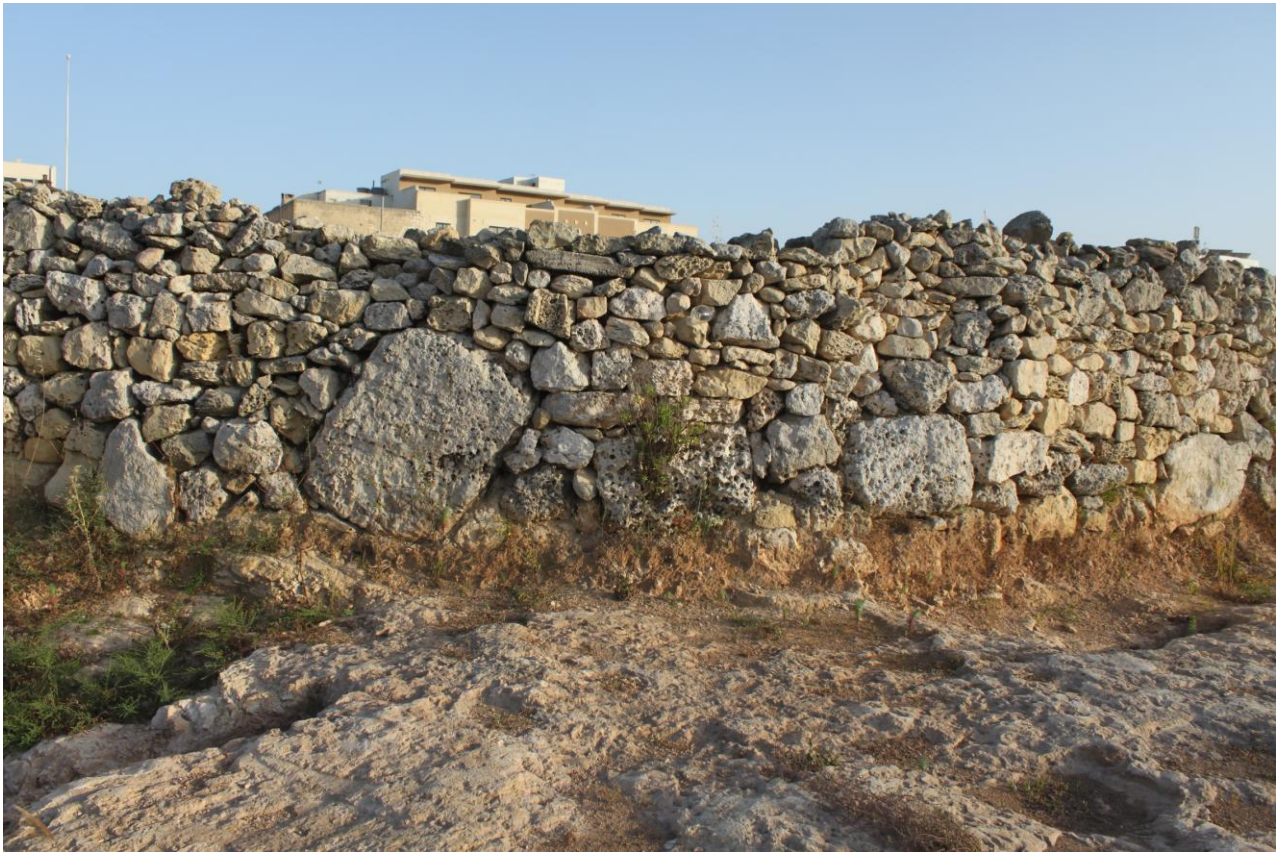
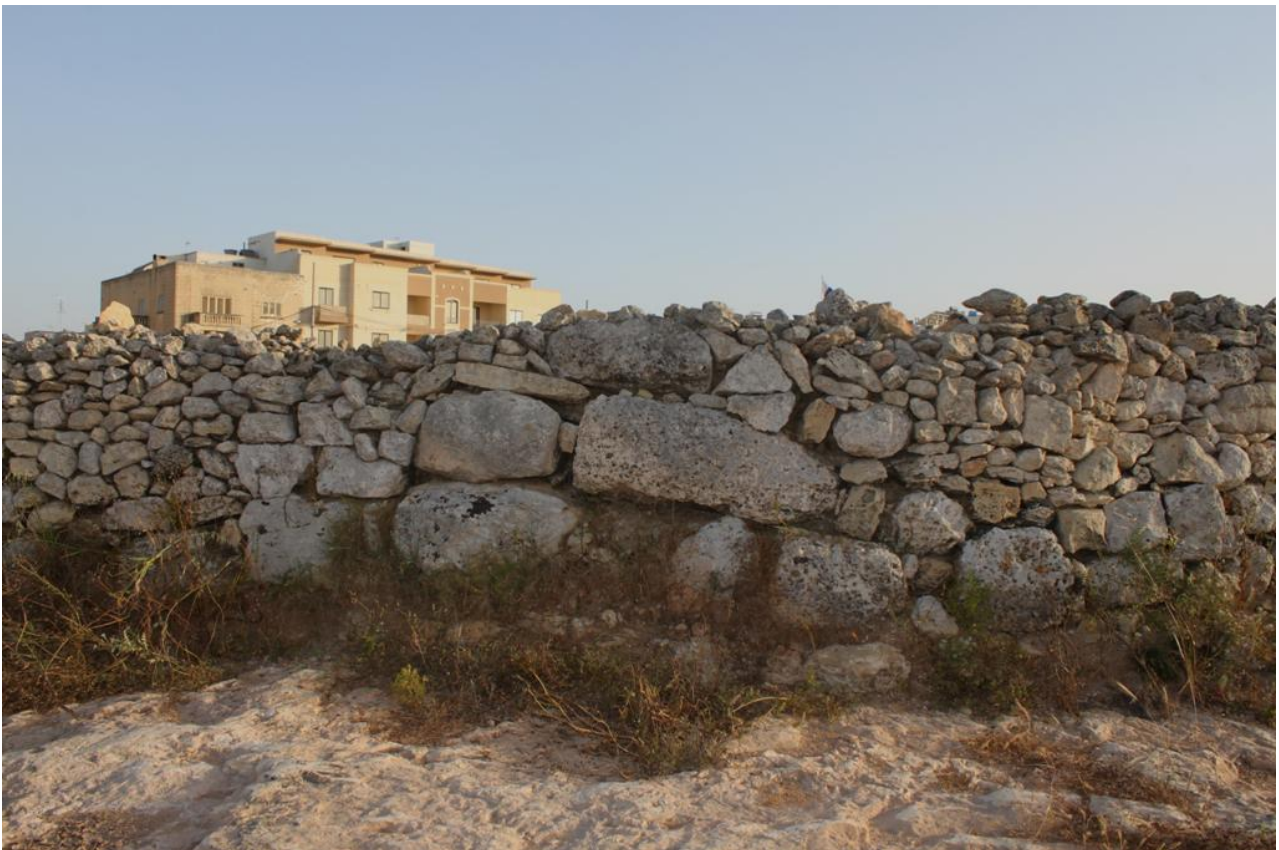
- A rubble wall which incorporates part of an ancient wall, built of large ashlar blocks (Feature 22 – **Plate 8**);
- A rock cut pit of undetermined function (Feature 26 – **Plate 9**);
- Various agricultural vine trenches (Feature 27 – **Plate 9**).

There is no objection to the inclusion of Field B in the Development Zone on condition that the following measures are observed:

1. The archaeological features noted in Field B are to be scheduled at an appropriate level of protection in terms of the Cultural Heritage Act and of the relevant Structure Plan Policies.
2. The archaeological data required to complete the documentation of this site must be finalised to the specifications of the Superintendence.
3. Rock-cutting for construction purposes should not impact the archaeological features recorded on the southern end of the field.
